# Manhole Inspection Summary

Manhole # S37A2\_010MH

Insp Date: **4/7/08 11:48 AM**

**Location** Address: **306 Frankle St.**

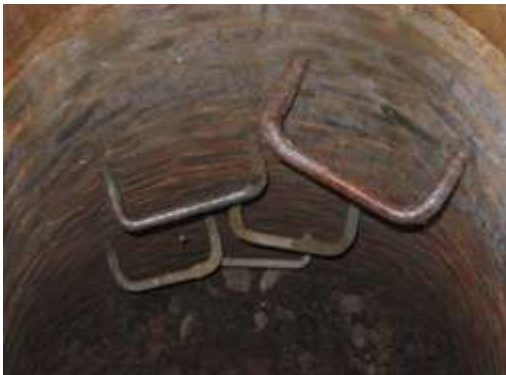
steps

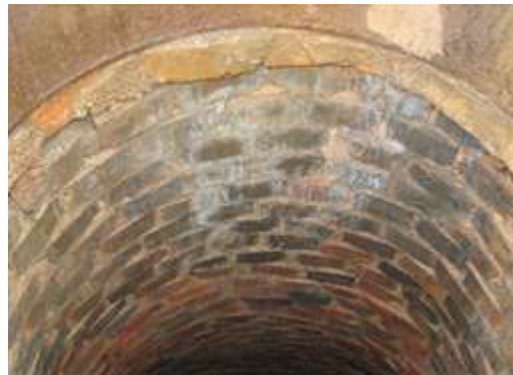
Defect 2

Condition: ☐ Sound ☒ **Cracked** ☐ Root Intrusion ☒ **Loose Brick** ☐ Deteriorated

Infiltration: ☐ None ☒ **Joint** ☒ **Cracks** ☒ **Mortar** ☐ Roots ☐ Wall

Infiltration through joint, crack and mortar

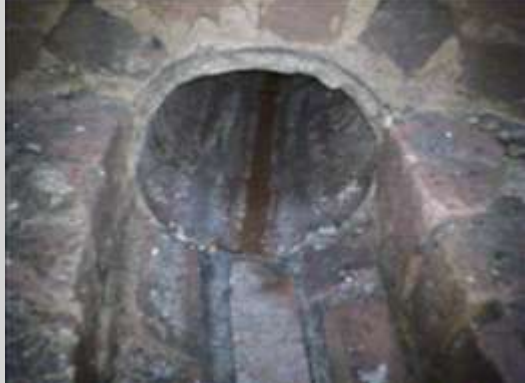
12 O'Clock Outflow

8 in. Circular Gravity Sewer  
Pipe Out @ 12 O'Clock

Pipe Height: **9.6** (in.) Rod and Bar (Angled)  
Pipe Material: **Clay** ☐ Pipe Lined  
Invert Depth: **10.22** (ft.) Flow Characteristics: **None**  
Deposits: ☒ None ☐ Mud ☐ Sludge ☐ Debris ☐ Grease  
Silt Depth: (in.) Deposits Extent:  
Infiltration: **None** Pipe Seal Cond: **Sound**

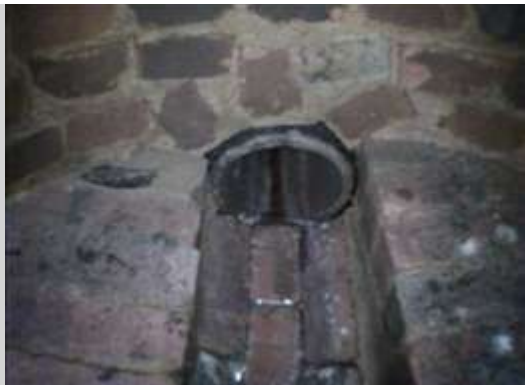
6 O'Clock Inflow

8 in. Circular Service Sewer  
Pipe In @ 6 O'Clock

Pipe Height: **7.2** (in.) Rod and Bar (Angled)  
Pipe Material: **Clay** ☐ Pipe Lined  
Invert Depth: **9.70** (ft.) Flow Characteristics: **None**  
Deposits: ☒ None ☐ Mud ☐ Sludge ☐ Debris ☐ Grease  
Silt Depth: (in.) Deposits Extent:  
Infiltration: **None** Pipe Seal Cond: **Cracked**
